Manhole Inspection Summary

Manhole # S35QQ_041MH

Insp Date: 1/19/07 3:18 PM

Location Address: **2453 BARCLAY ST**

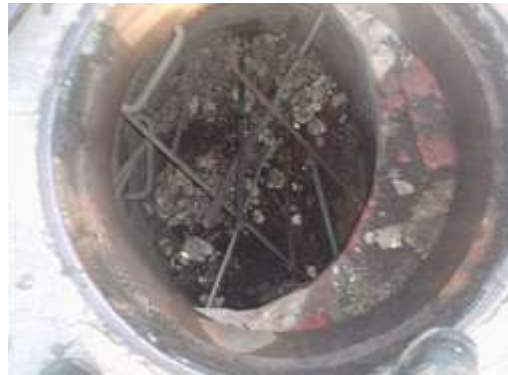
Top View

Channel debris.

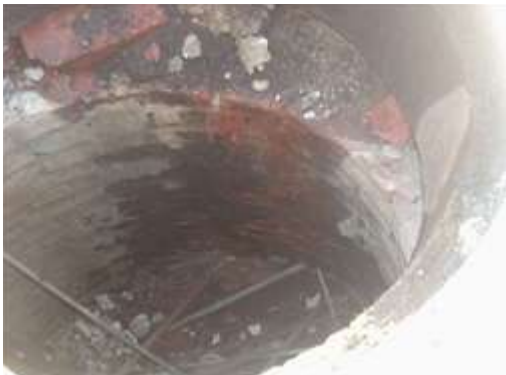
Defect

☒ **Leaks**

Condition: ☐ Sound ☐ Cracked ☐ Root Intrusion ☐ Loose Brick ☒ **Deteriorated**

Infiltration: ☐ None ☒ **Joint** ☐ Cracks ☐ Mortar ☐ Roots ☒ **Wall**

Infiltration: ☐ None ☐ Joint ☐ Cracks ☐ Mortar ☐ Roots ☒ **Wall**

Frame leaks. Frame offset. Adjustments deterioration and infiltration. Barrel infiltration.

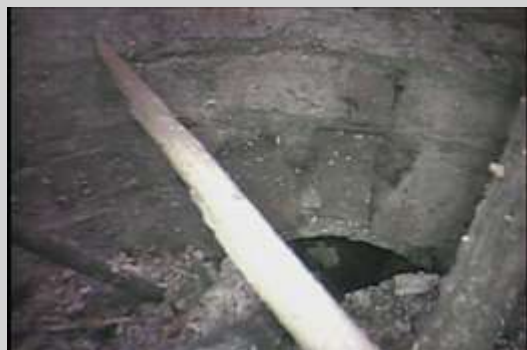
Pipe Out @ 12 O'Clock

Deposits: ☐ None ☐ Mud ☐ Sludge ☒ **Debris** ☐ Grease

Silt Depth: **6** (in.)

Deposits Extent: **Heavy**
